Bexhill Environmental group

28th June 2023

from
**Southern
Water**

Bexhill bathing water results

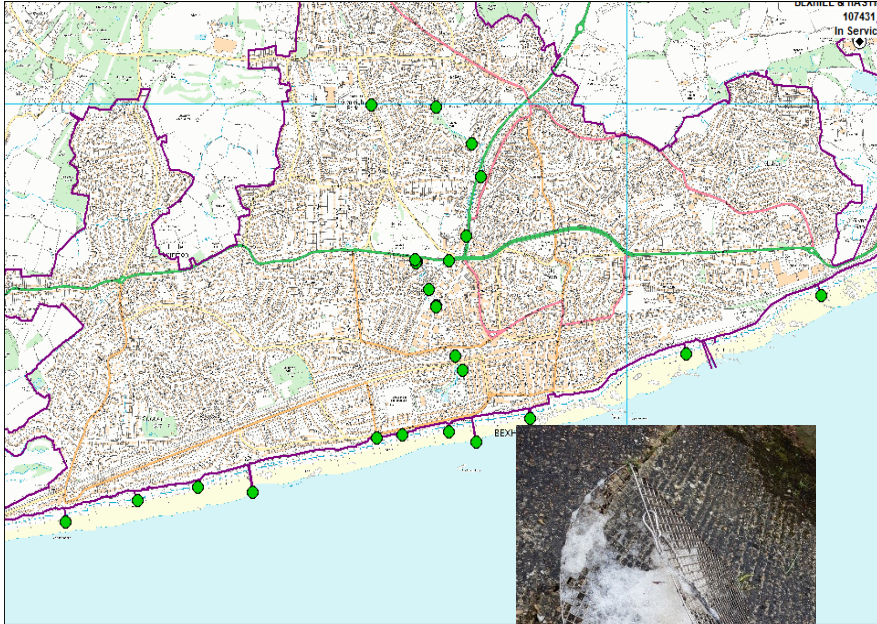
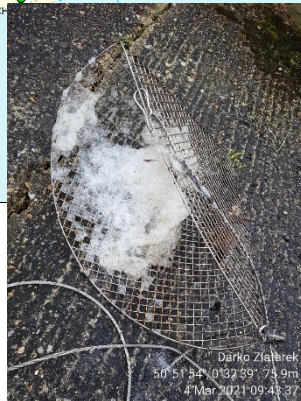
Cage Survey

- Cages act like traps, are prefabricated steel and come in a range of sizes to fit most sewers
- Cages installed within the surface water network in strategic locations to catch incoming lines
- Cages were kept in place for 2 weeks then removed with observations logged
- No evidence of household waste observed
- Where outfalls were not accessible, sample was taken instead

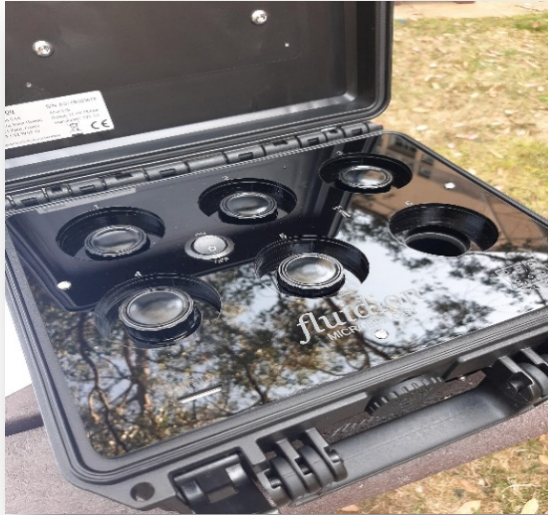
What is fluidion? - A portable device which allows the user to test out in the field with an easy to carry portable lab.

- Sample setup time 15 minutes
- GPS and GSM connectivity to fluidion.com
- 6 samples
- Measures level of E.coli in clear water and saline conditions
- Results within 2-8 incubation

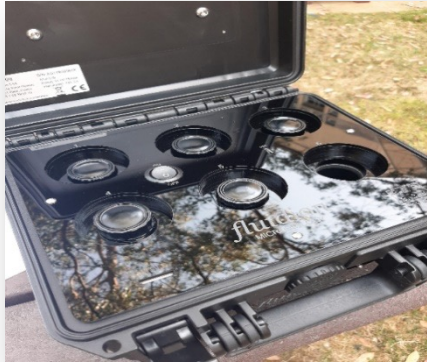
- Frequent sampling throughout bathing water season
- Near real time results using Fluidion Auto Sampler (can analyse 6 samples)
- 14 sample locations including official EA Bathing Water sample point
- Expert analysis and specialist response standing by to act on any high results

- Sample setup time 15 minutes
- GPS and GSM connectivity to fluidion.com
- 6 samples
- Measures level of E.coli in clear water and saline conditions

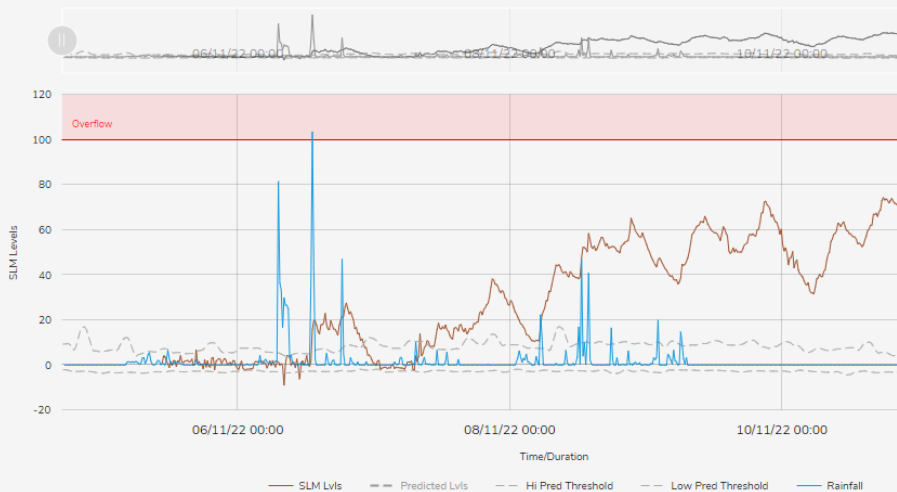
DATA VISUALISATION | S202003287 - SZ61993209 - HORNET CLOSE SEAFIELD CLAYHALL

Last Week

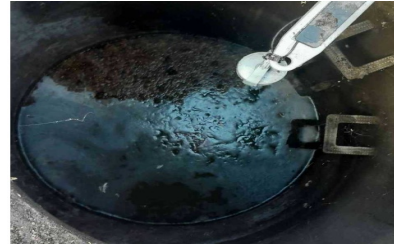
Before

- Alerted 24/10 for Levels above expected. Job raised and attended same day.
- Blockage located and cleared with high pressure water jetting.
- Sewer level returned to normal with no impact to customers or the environment
